REPORT OF

Dr D P O'Callaghan

Accident as a result of a Fallen Tree Clavey's Farm, Mells, Frome, Somerset 11 July 2001

OCA UK Limited

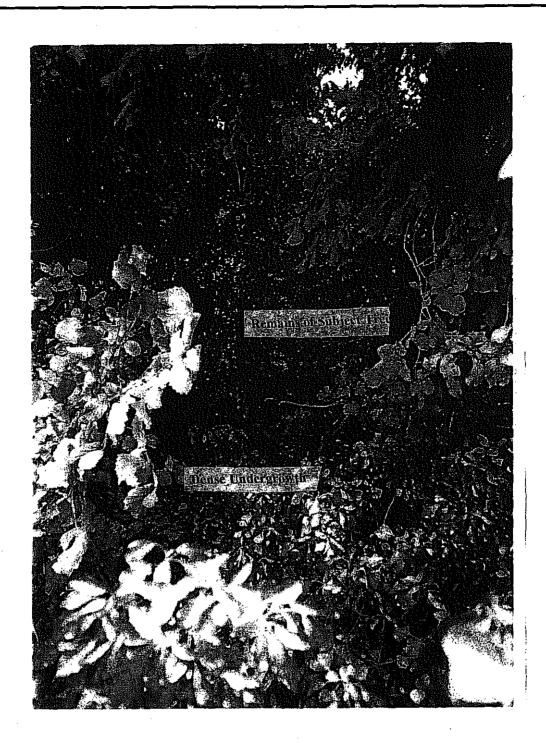
Appendix 3-1: Photograph 1

Position of the base of the subject tree masked by dense undergrowth.

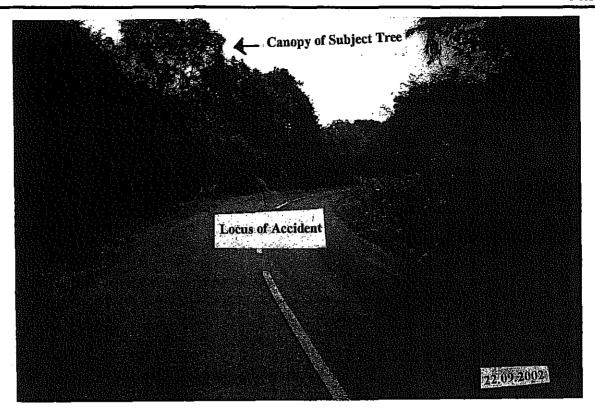
Appendix 3-3: Photograph 1

Picture of the locus of the accident taken on 22 September 2002 showing the crown of the subject tree in full leaf.
