REPORT OF

Dr D P O'Callaghan

Accident as a result of a Fallen Tree Clavey's Farm, Mells, Frome, Somerset 11 July 2001

OCA UK Limited

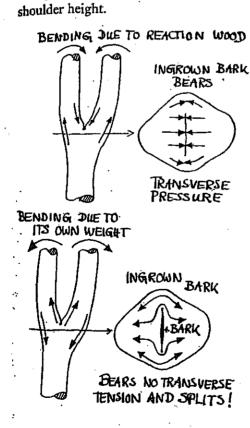
- 4.5 The evidence for the included union in the subject tree is shown on Photograph 4 at Appendix 3-2. In reality, the weakness of these unions is such that they can fail when a force is exerted upon them at right angles, a sudden gust of wind for example. Professor Claus Mattheck explores this subject in detail in his book, "The Body Language of Trees" (DoE Publication No 4 in Research for Amenity Trees, HMSO 1994 ISBN 0 11 753067 0). In Chapter 5 at Figure 35 (Appendix 6-1) Professor Mattheck says the following in regard to included unions

Fig 35. The compression fork, optimized for withstanding the pressure of the two stems pressing against each other, is a structure that is absolutely bound to fail if a tensile load is applied at right angles to the axis of the stems, pulling them apart.
